ENVIRONMENTAL ASSESSMENT WORKSHEET

1. Project title: CROW RIVER HEIGHTS WEST FUTURE ADDITIONS

2. Proposer: Backes Development, LLC

3. RGU: City of Hanover

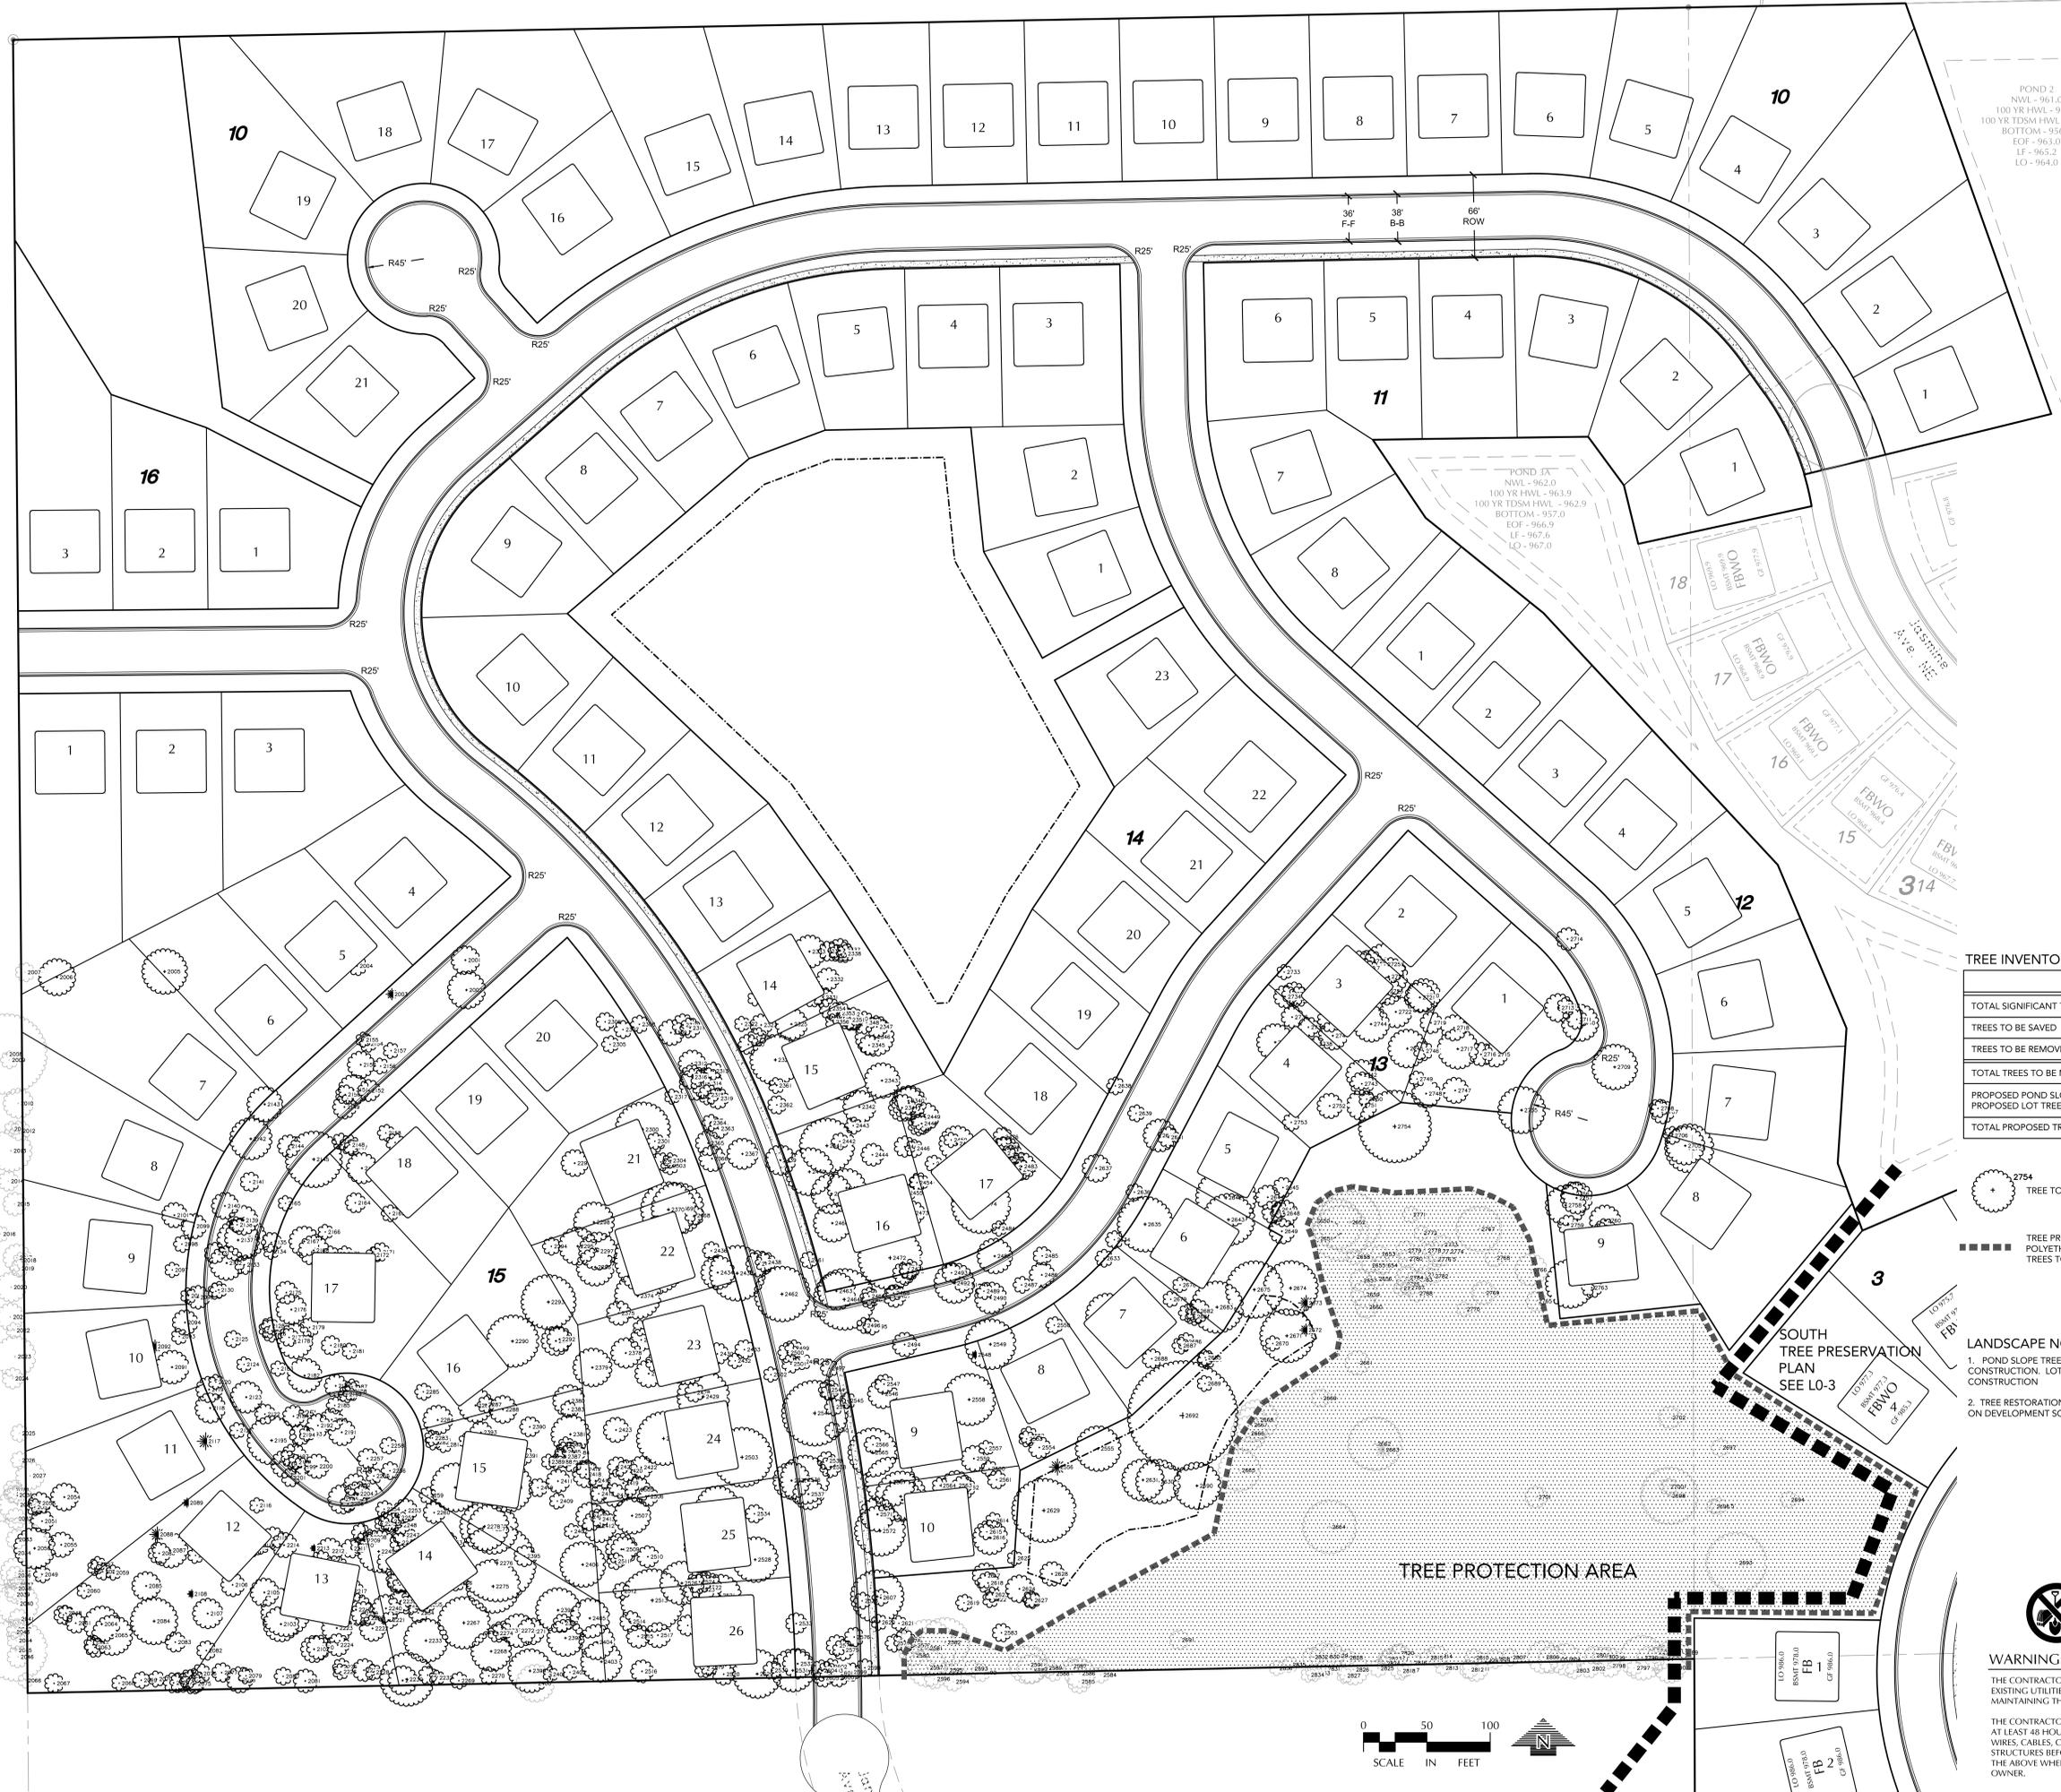
POND 2
NWL - 961.0
100 YR HWL - 962
100 YR TDSM HWL -
BOTTOM - 956.0
EOF - 963.0
LF - 965.2
LO - 964.0

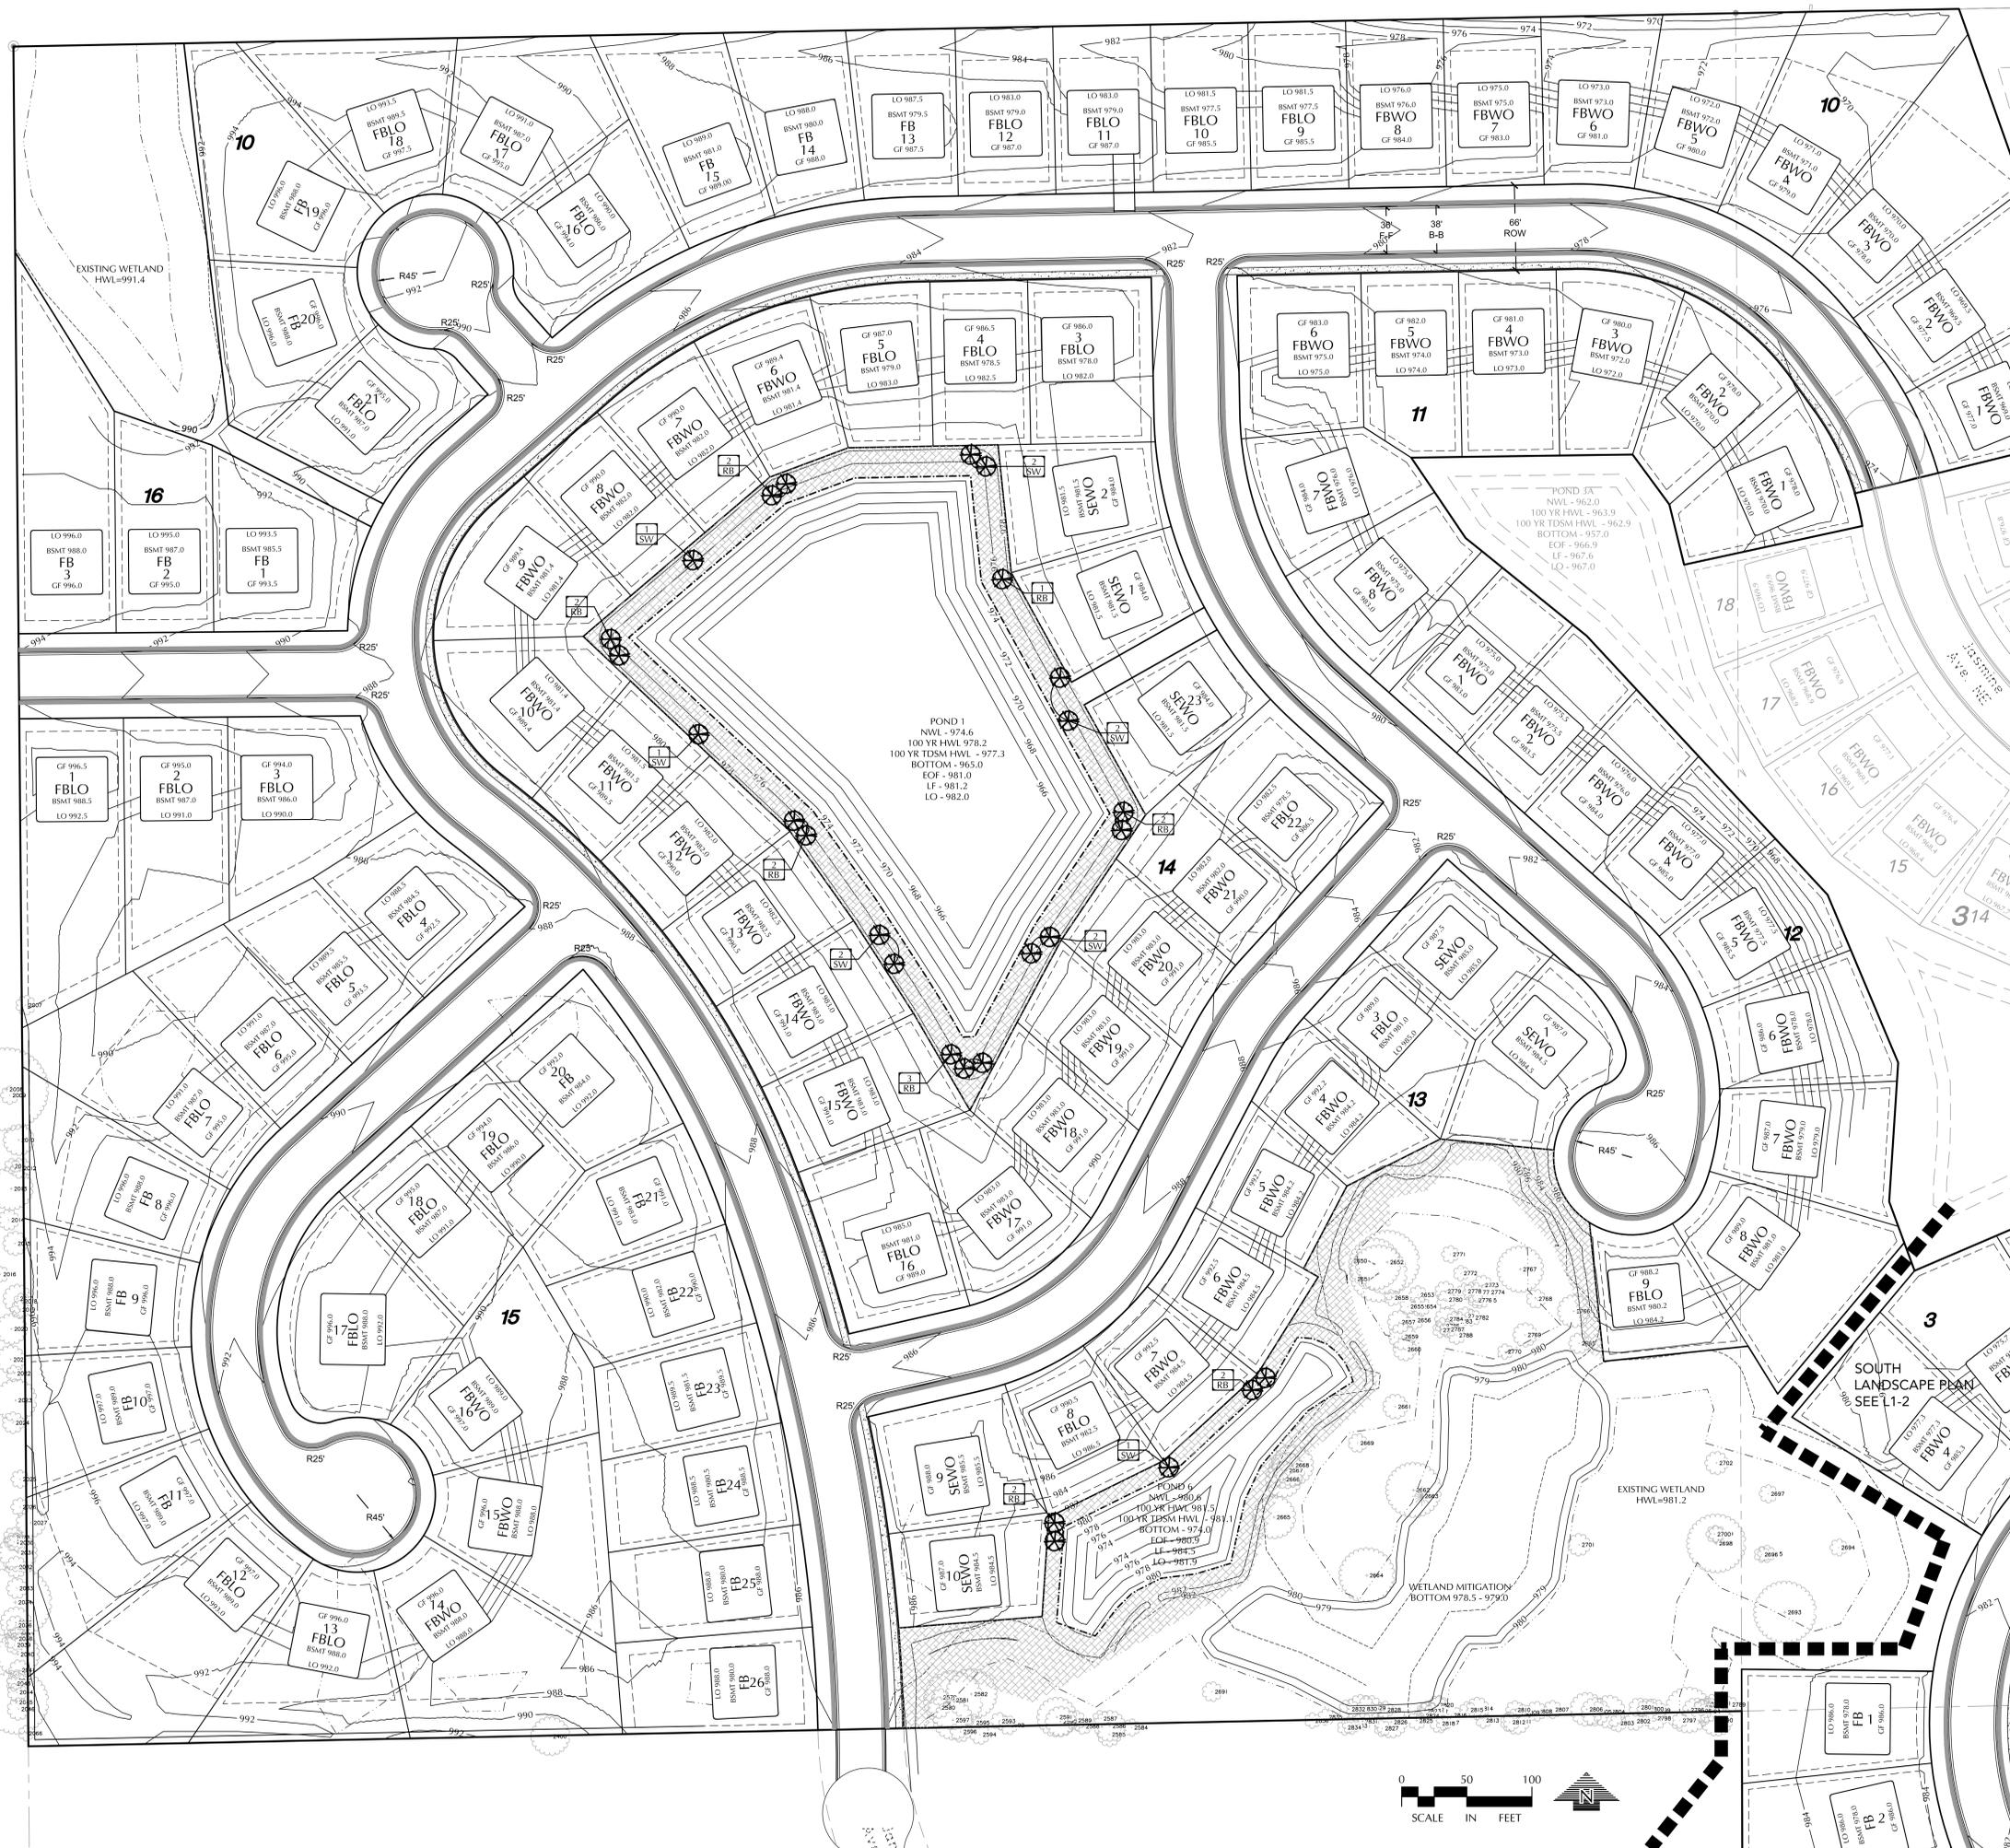
POND 2
 NWL - 961.0
 100 YR HWL - 962.0
 100 YR TDSM HWL - 964.0
 BOTTOM - 956.0
 EOF - 963.0
 LF - 965.2
 LO - 964.0

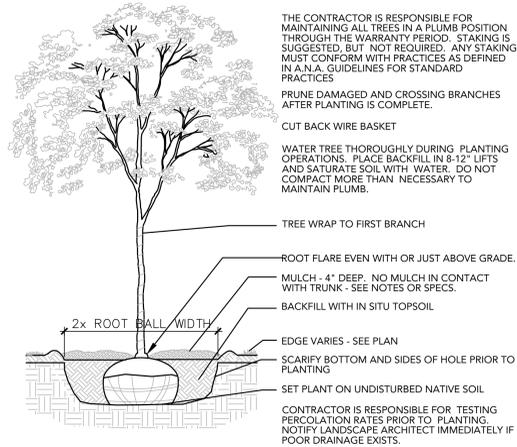
1
L2-1
DECIDUOUS TREE PLANTING DETAIL
SCALE: 1/2" = 1'-0"
Deciduous Tree.DWG

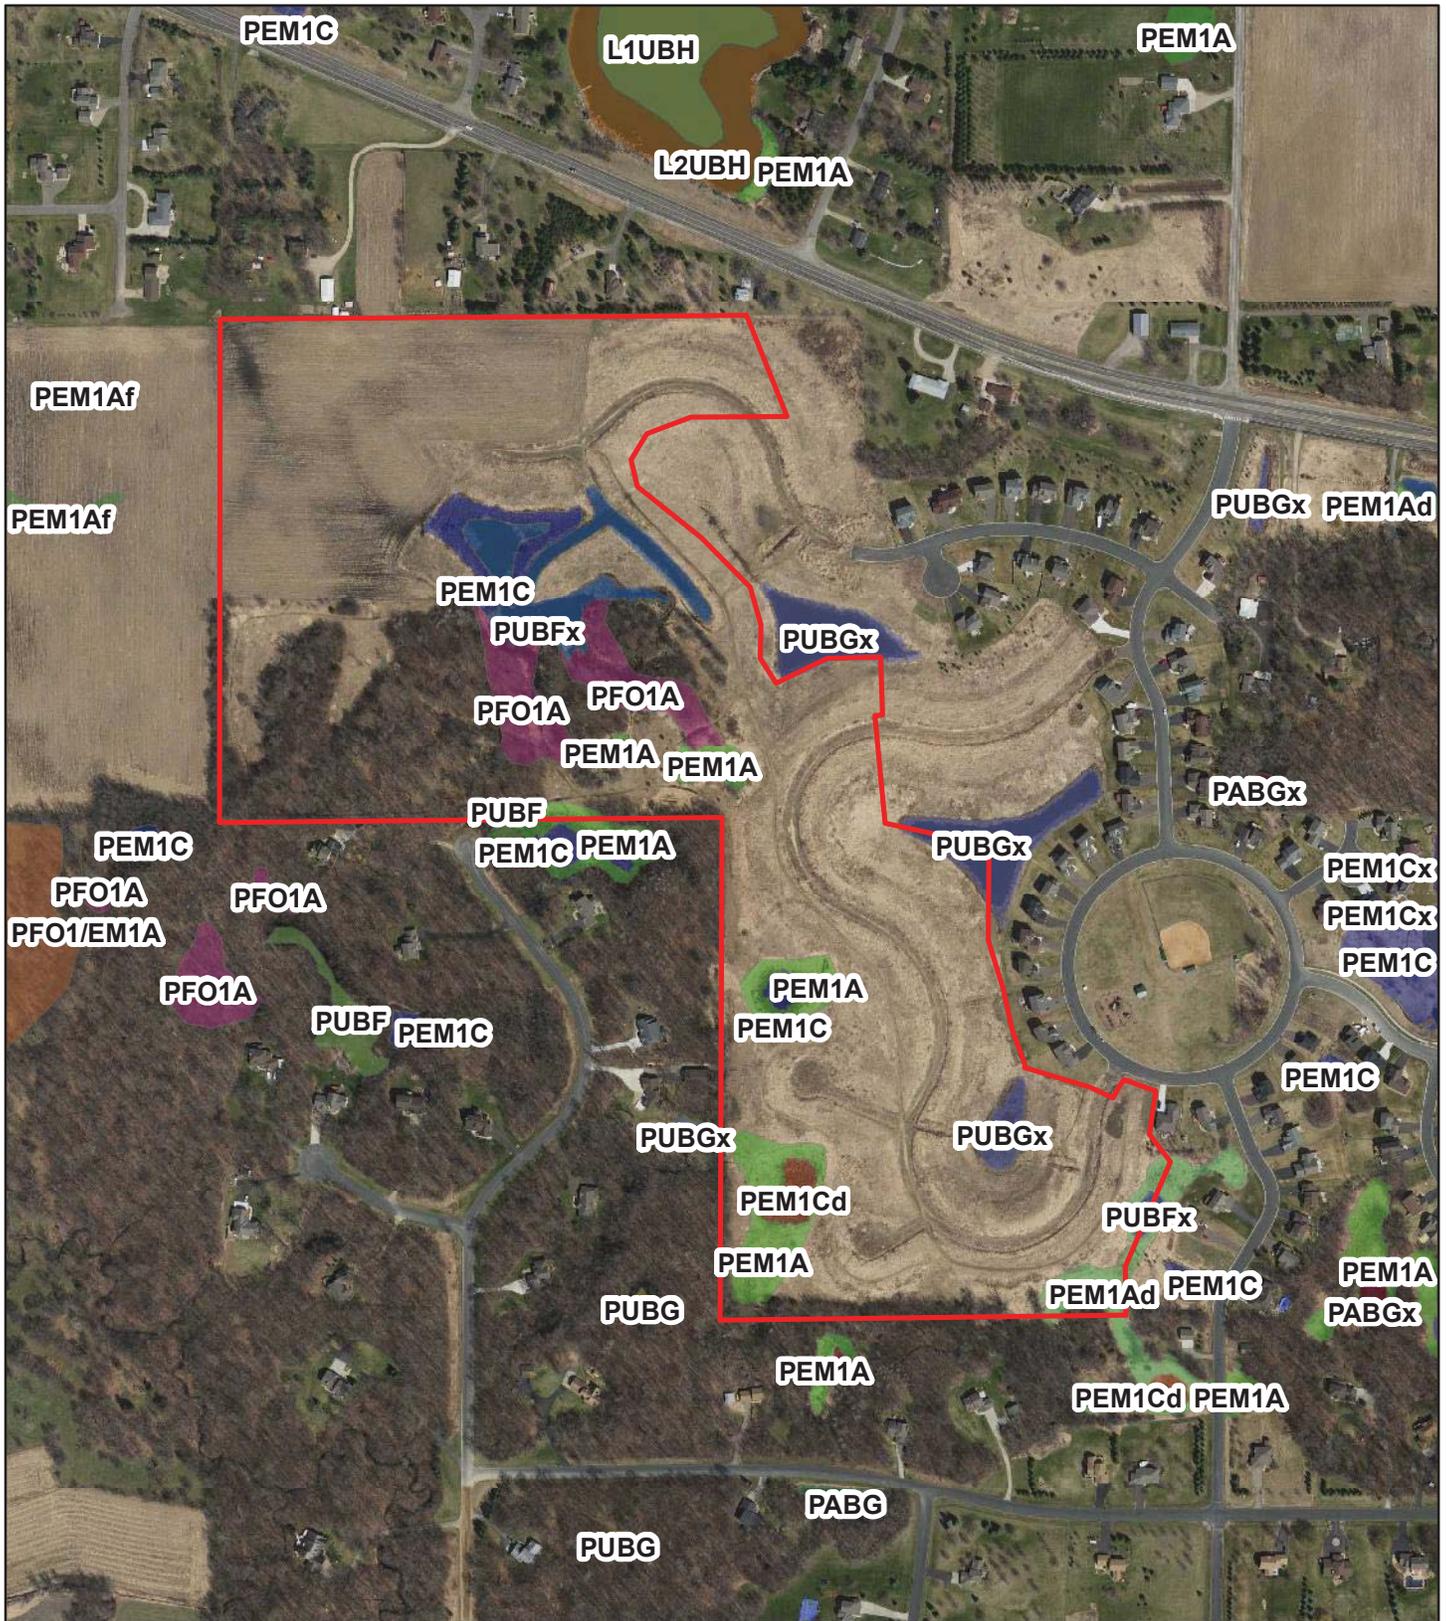
Figure 3 - National Wetlands Inventory

In April, 1999 a wetland delineation was conducted by Kjolhaug Environmental Services for the original project and was subsequently re-approved in October, 2005. On May 3, 2017 the wetlands were re-delineated by Kjolhaug Environmental Services for the subject site and 12 wetlands were delineated. The 12 wetlands are larger in size than the same wetlands delineated in 1999. The cause of the increased size was due to incidental impacts caused by the site preparation of the larger development. (**Attachment 10, Wetland Delineation & No-Loss Report**)

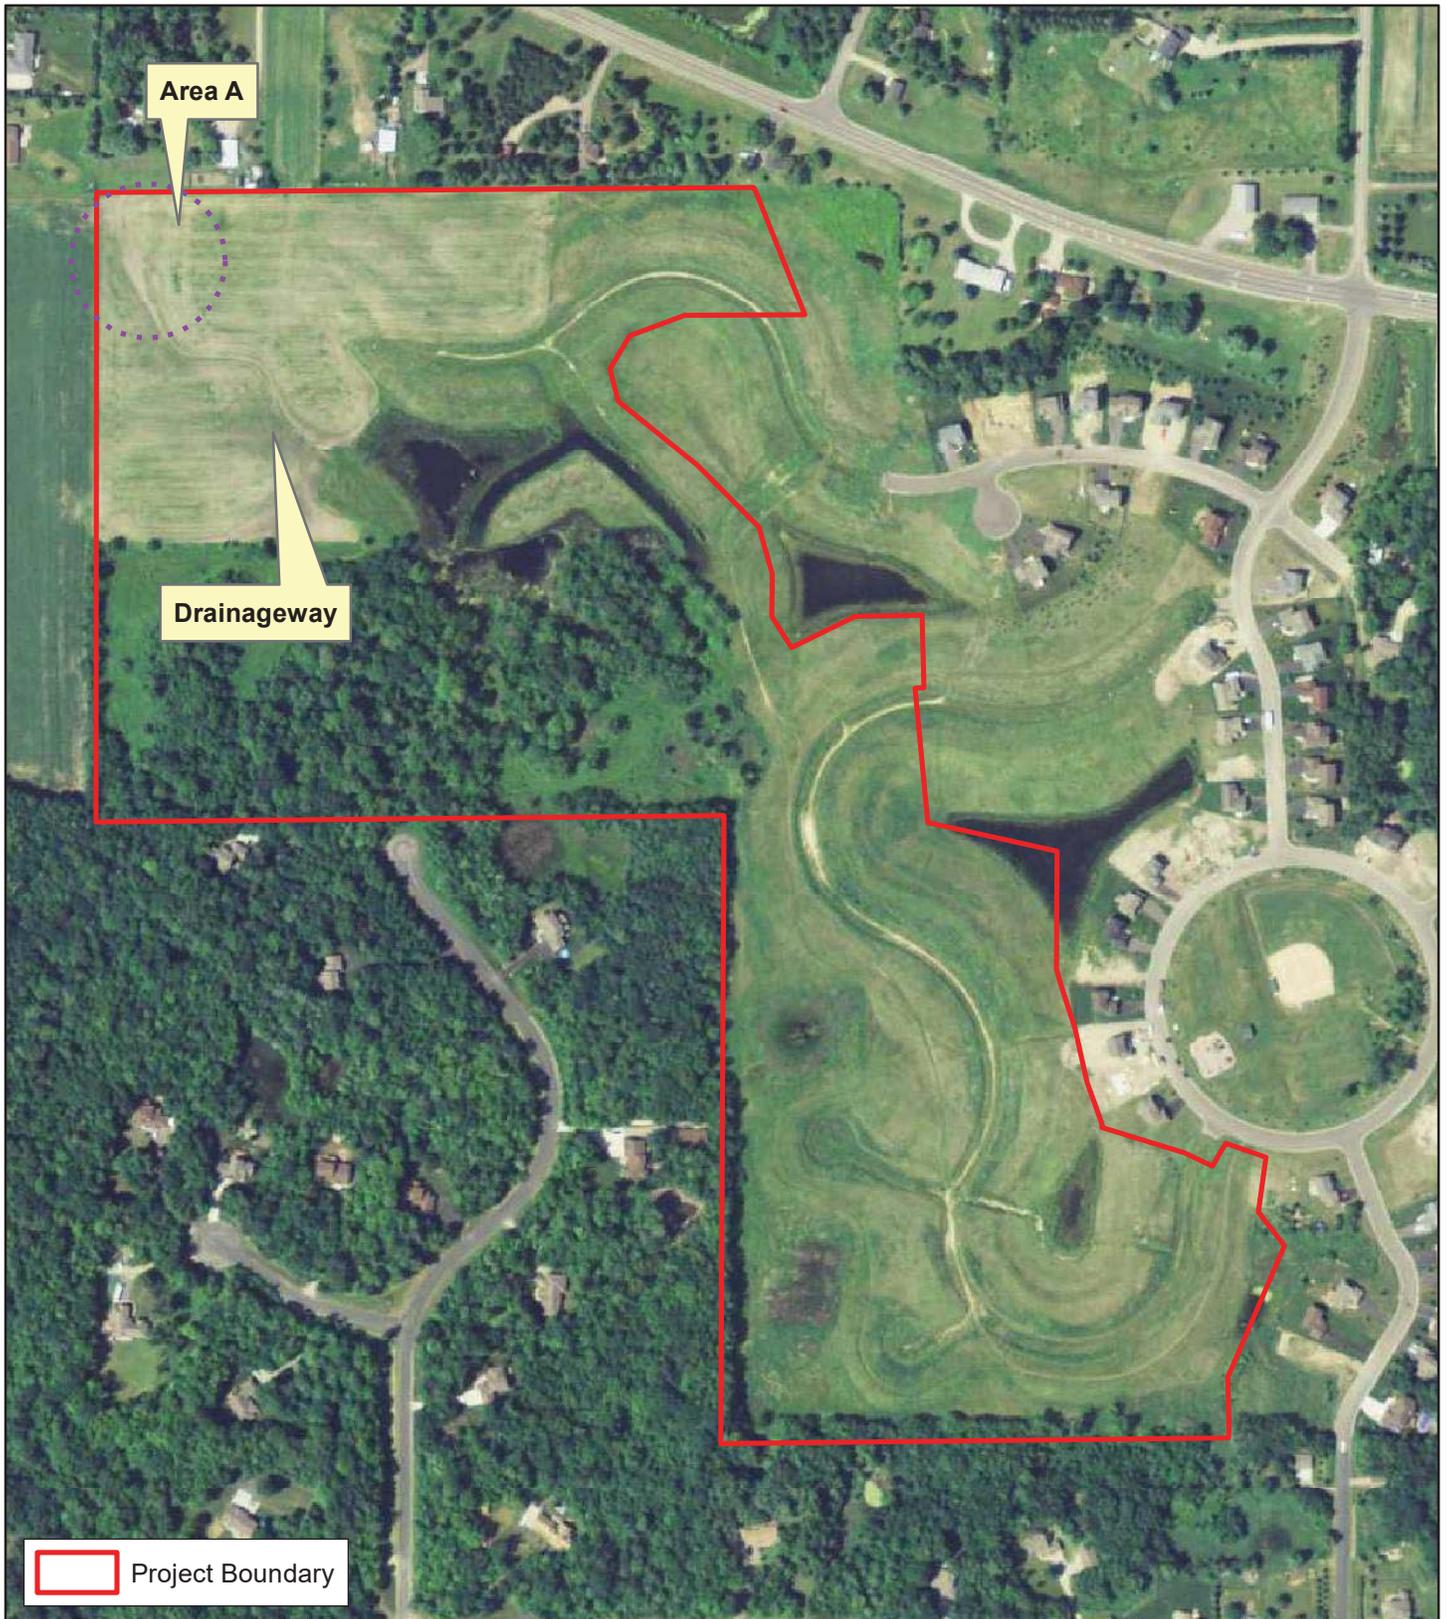
Figure 7 - Offsite Hydrology Assessment Areas (2013 FSA Photo)

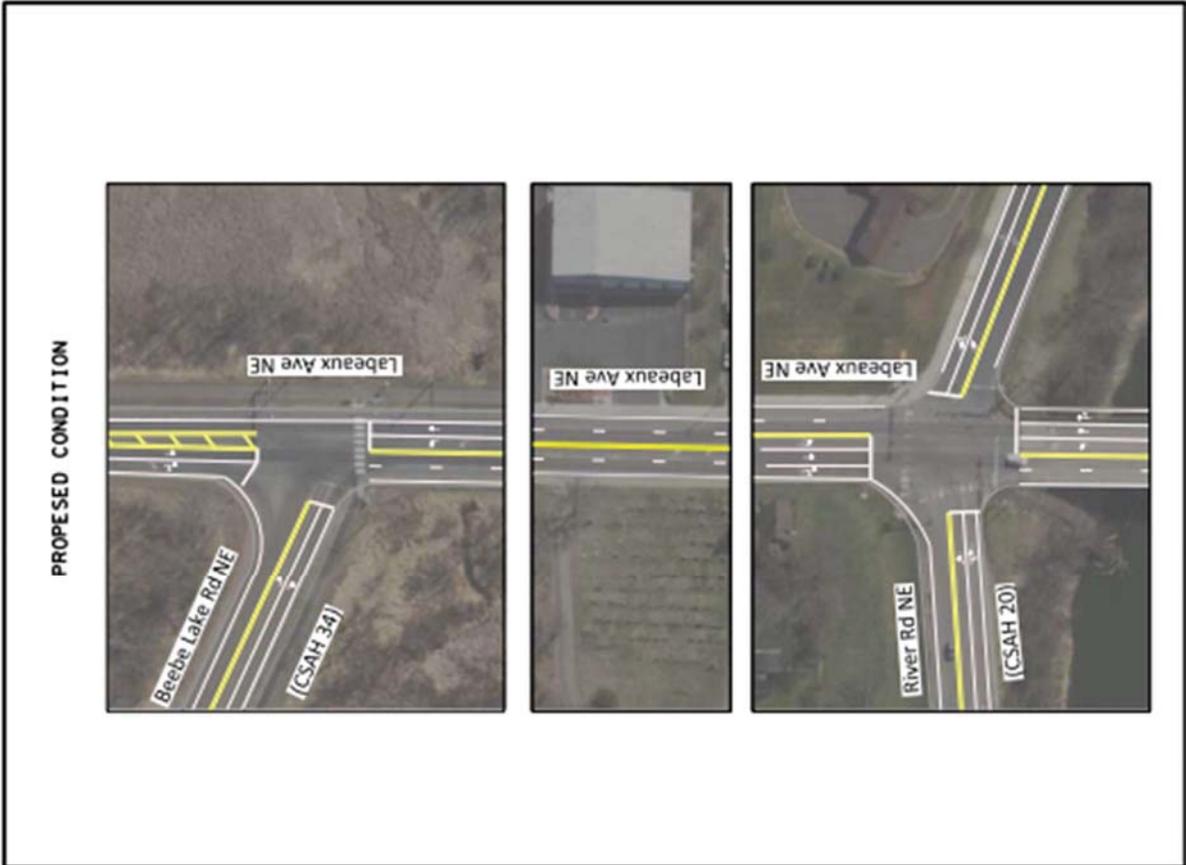
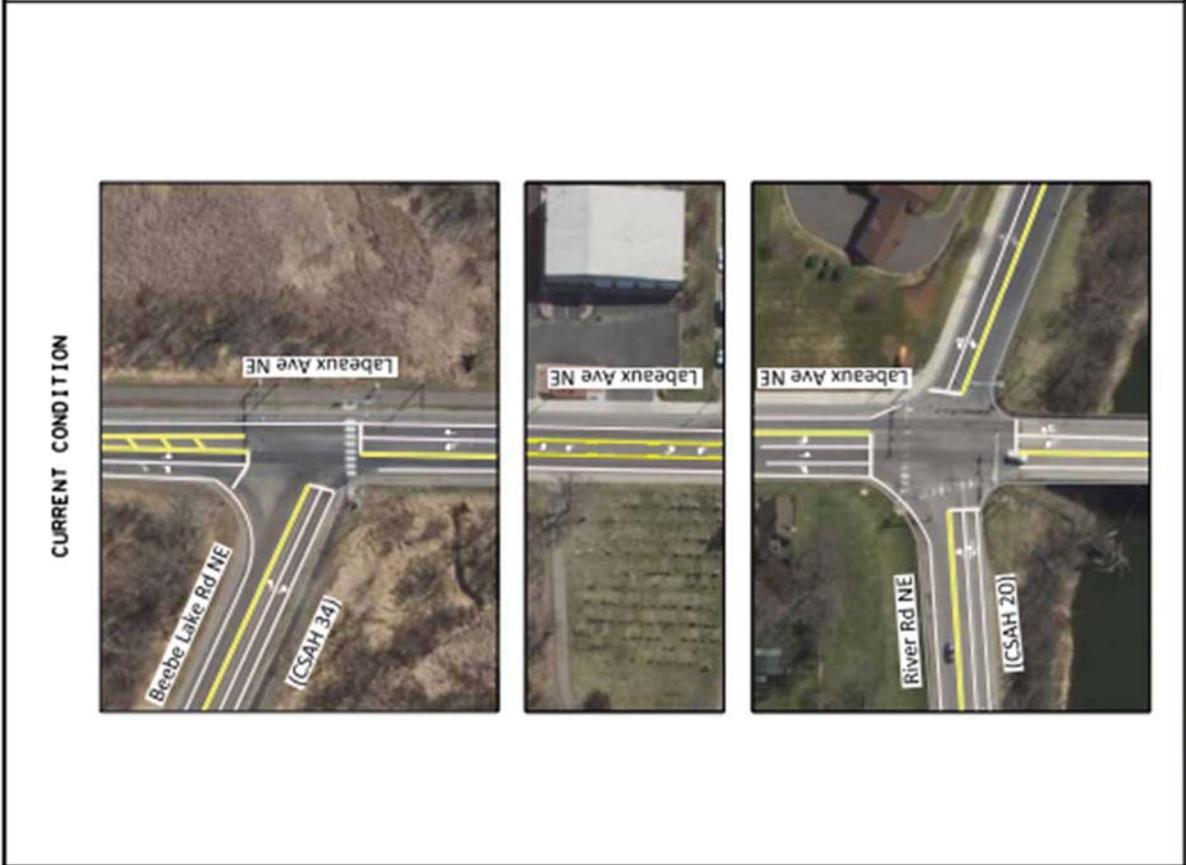
It is assumed that capacity improvements will occur between now and 2040 that will result in improved operations. Traffic operations have been tested for the suggested improvements, and the results for the mitigated 2040 No-Build conditions are summarized in Table 5.

**PROPOSED IMPROVEMENTS
FIGURE 10**
